ADVISORY NOTICE

Document: 4555 / 01

RX2 Relay Possible Incorrect Contact

Product: ZooMax LC Family; Milestone LC Family (*3-phase input version only*)

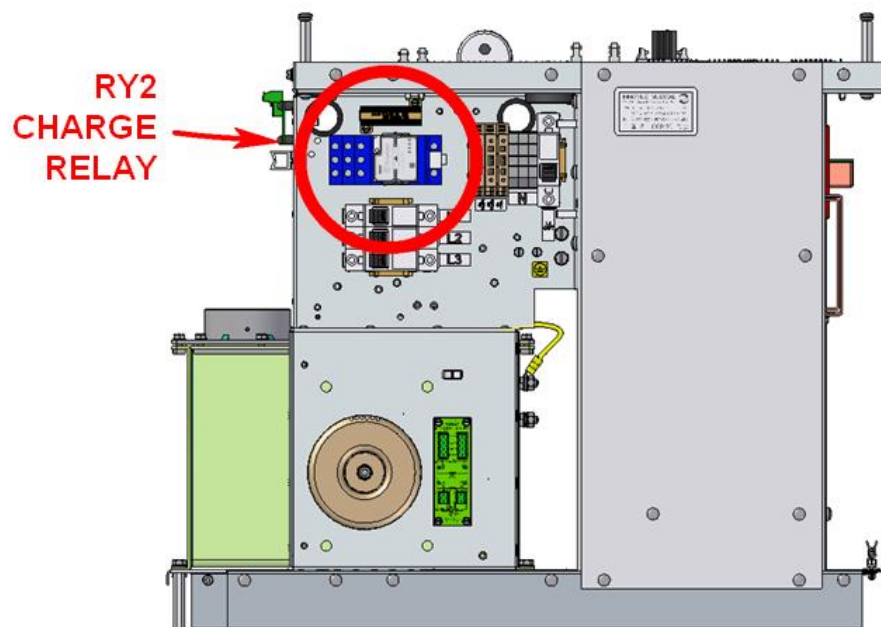
During shipment, the RX2 slow charge relay may become loose preventing the generator from charging the capacitor bank. Either the generator will display WARMING UP... message during startup and cannot go into ready state or it will automatically turn itself off after several seconds.

The RX2 relay is mounted in a standard PTF / PYF socket sideways and is held in place by a wire clip type retaining clip.

Milestone LC Generator side view with RX2 relay

1. During installation, make sure that:
 - a. RY2 is seated well in its socket
 - b. and the retaining spring clip holds it firmly in place. If necessary, replace the retaining clip with a compatible type, e.g. SY2S-02F1 (pullover wire spring type, IDEC):
